PB-2000C repair, upgrade and maintenance log

Tech Log Entry

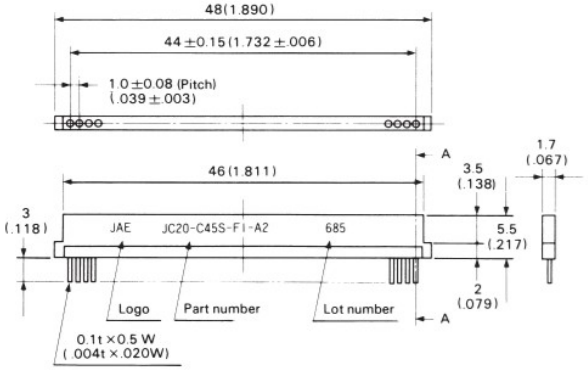
The card side uses a JAE JC20-C45S-F1-A1 connector. A delicate 1mm pitch connector with low tolerances.

Note the similarity between the extracted contact and Section A-A above.

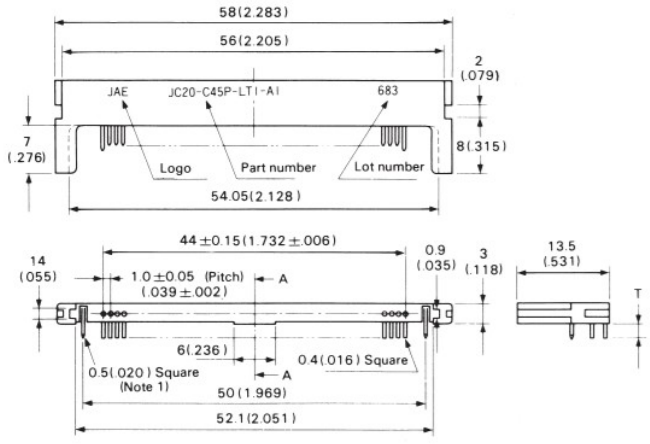
■ JC20 SERIES C TYPE CONNECTORS • PIN CONNECTOR FOR SYSTEM SIDE

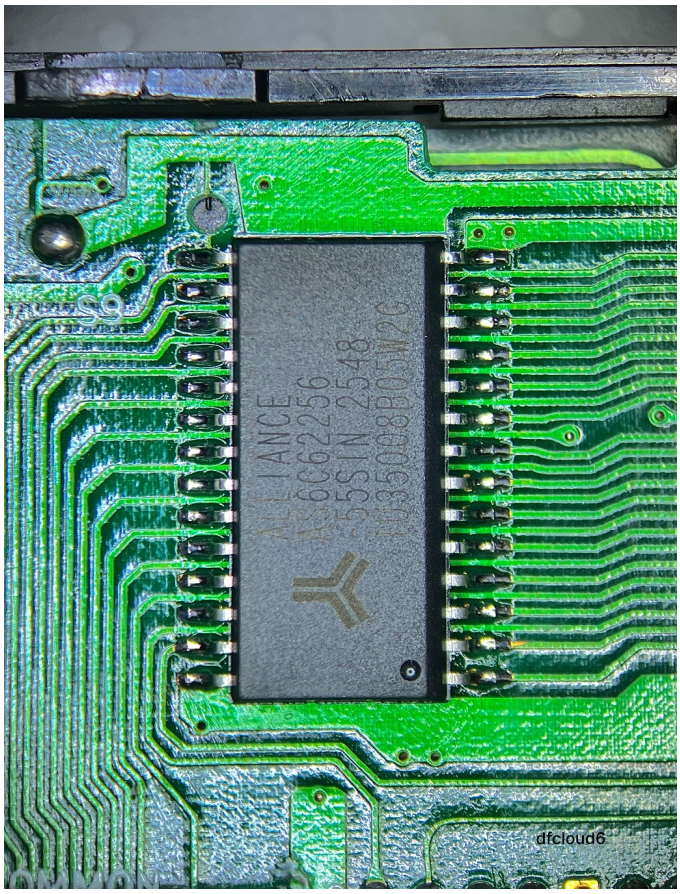
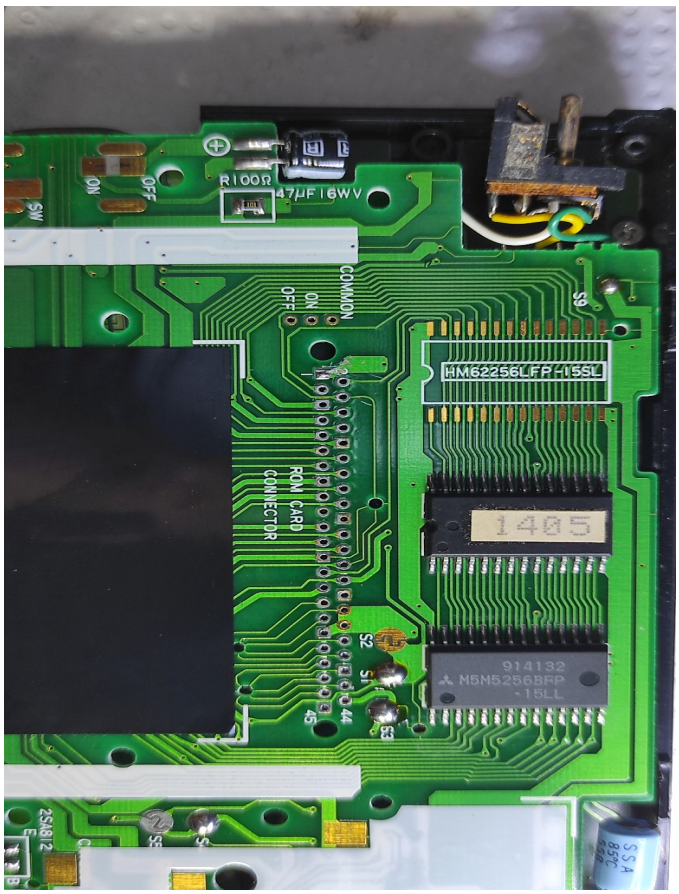
We sourced a AS6C62256-55SIN memory IC from DigiKey. Following the instructions, it was installed at the HM62256LFP-15SL silk label location (right).

IC already installed on the motherboard (left).

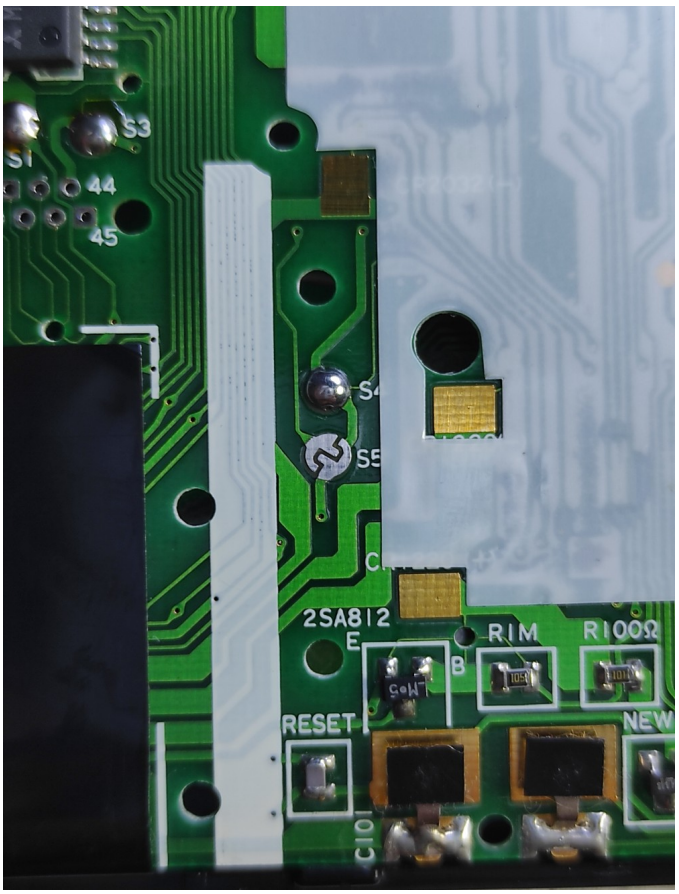
Next, per the instructions, the operation of jumpers S4 and S5 was reversed (right).

Finally, CLEAR MON confirmed that the memory location was accessible.

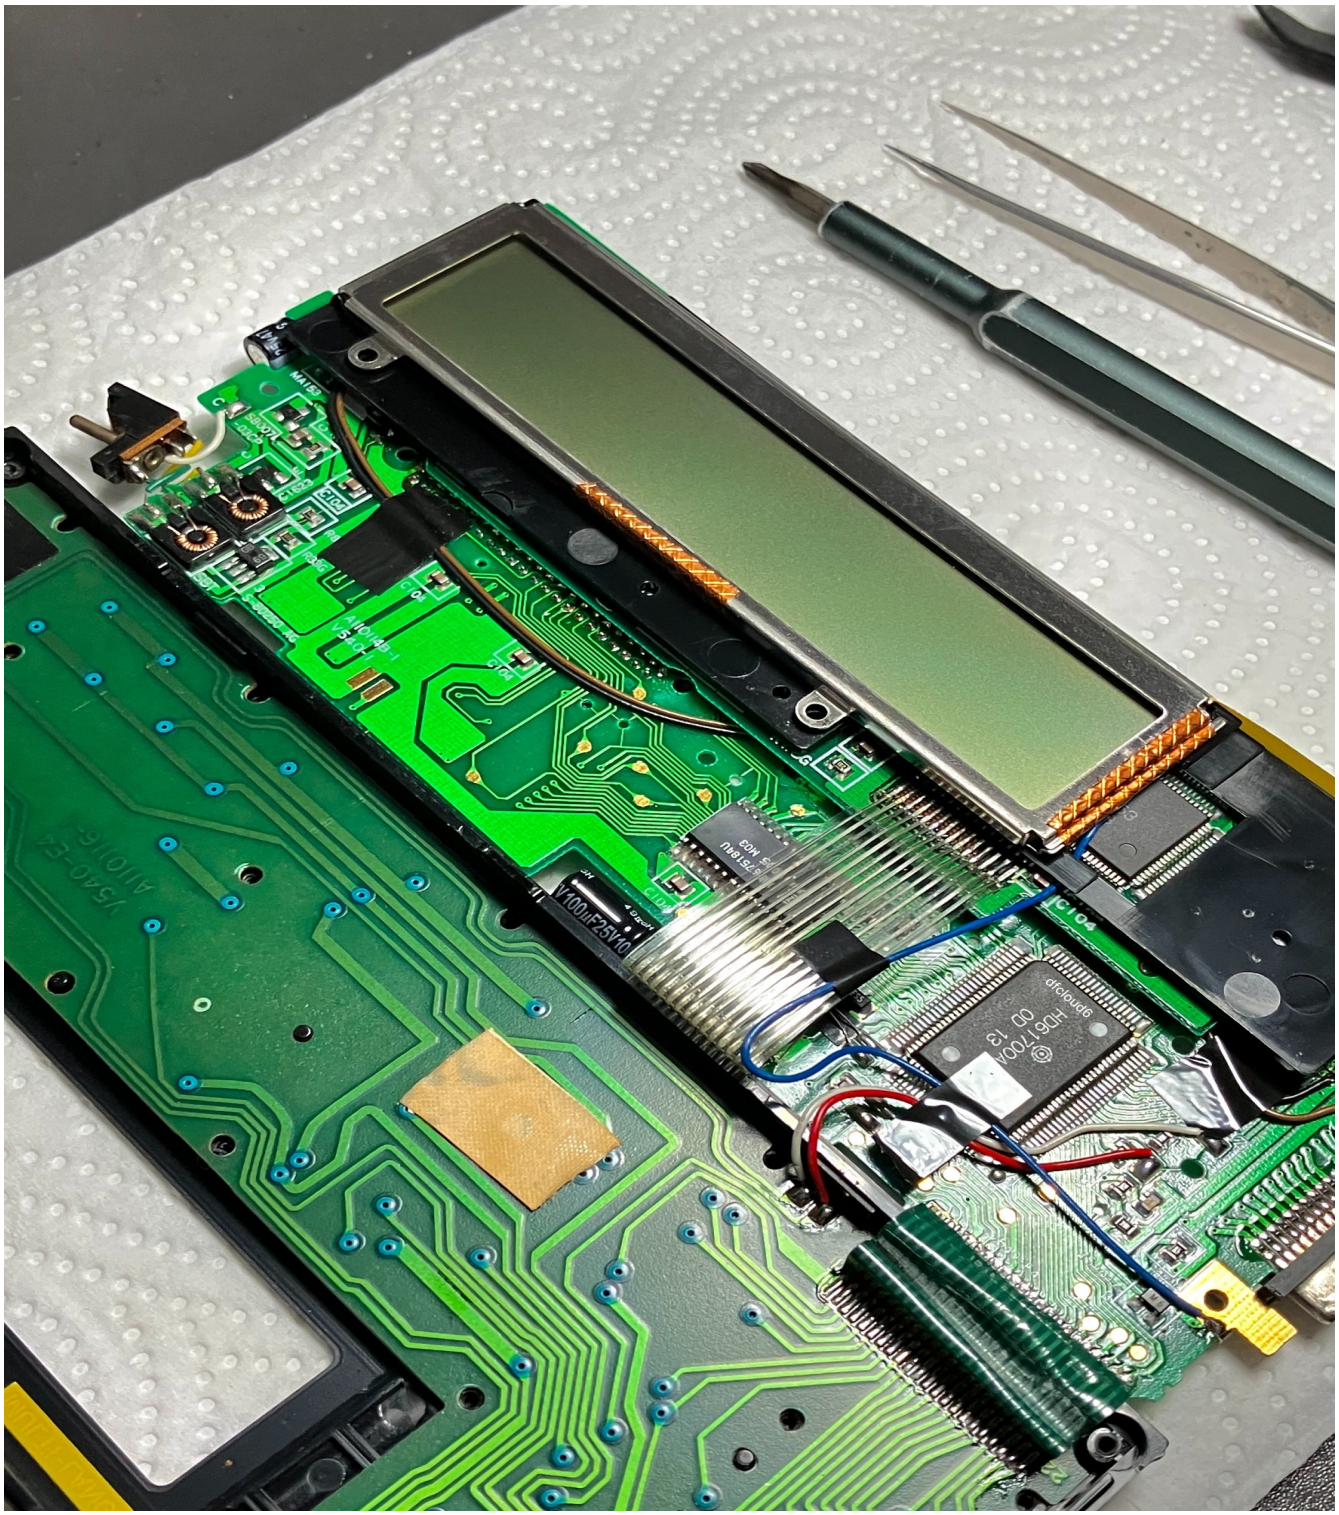
Daniel cleaned the dust from behind the display lens and gently applied isopropyl 99% to give her a fresh, almost “out of the box 1989” look.

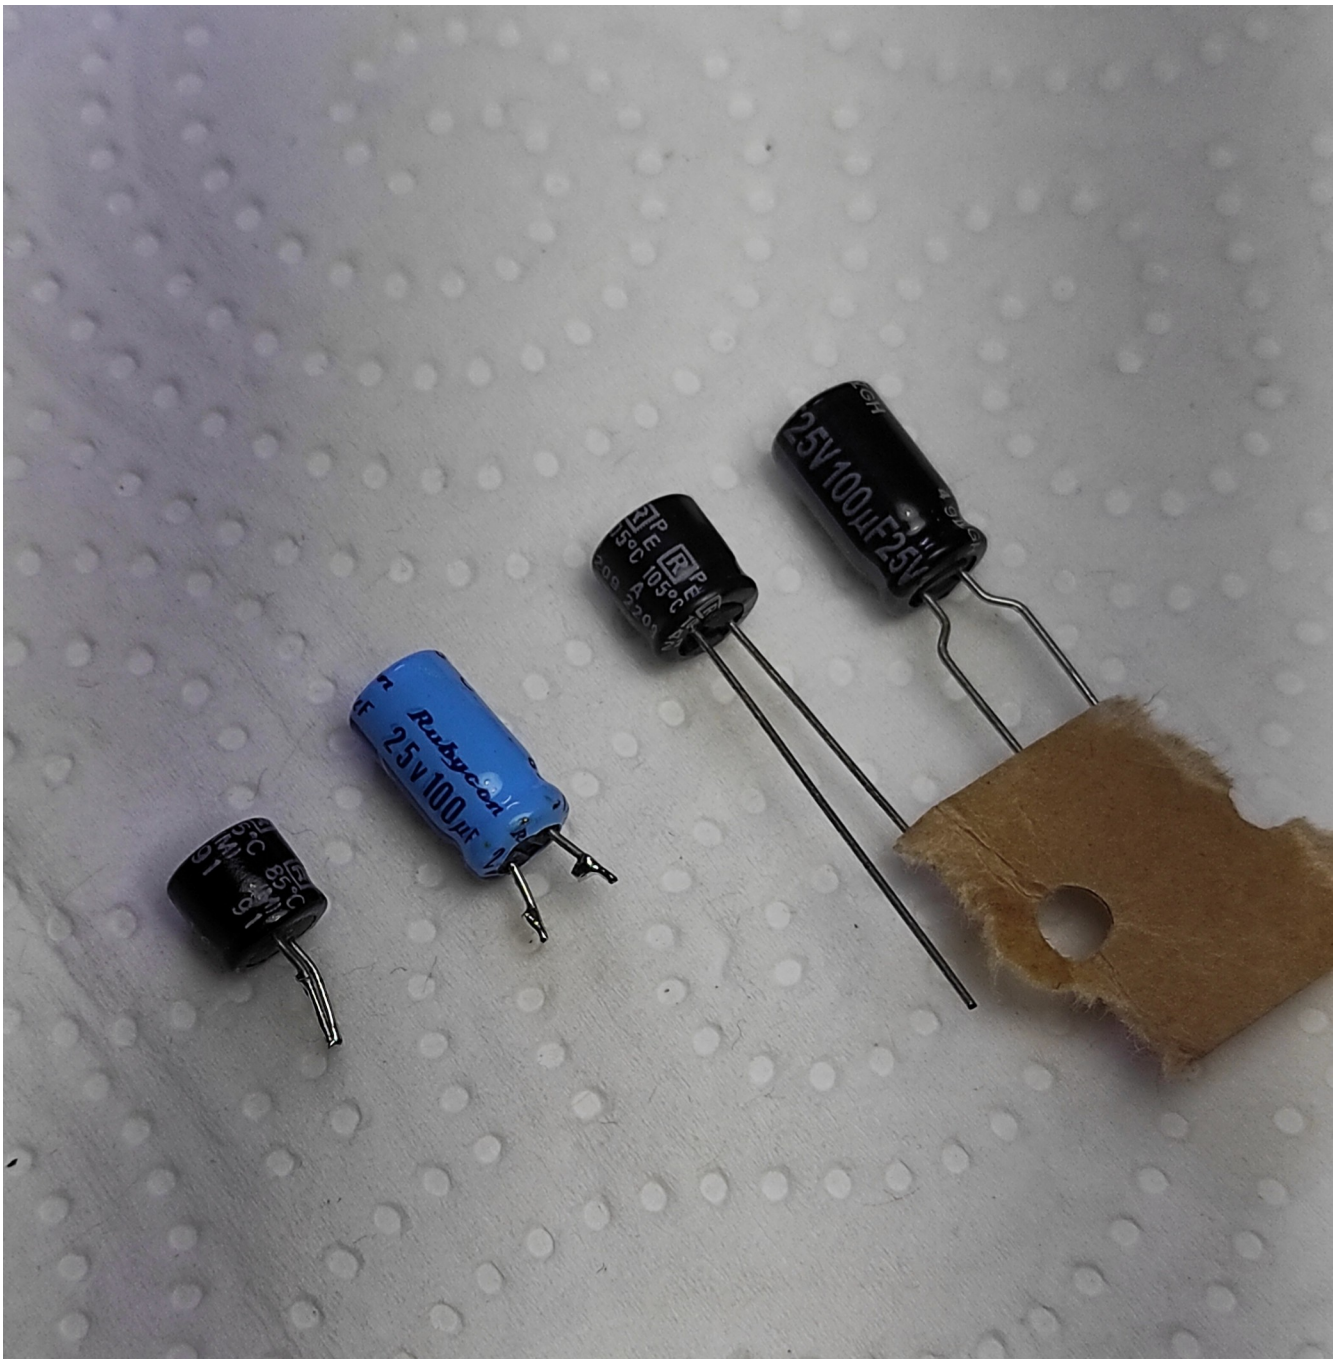
Next, the two main electrolytic capacitors were recapped. While some service manuals suggest tantalum replacements, high-grade Japanese electrolytic were chosen to preserve the board's original ESR (Equivalent Series Resistance) design specifications.

A family of aluminum electrolytic capacitors. Old ones on the left of the picture.
